## **Limited Visual Dam Safety Inspection Summary Report**

**MA-046**

**Waikamoi Dam Number 2**

**May 2006**

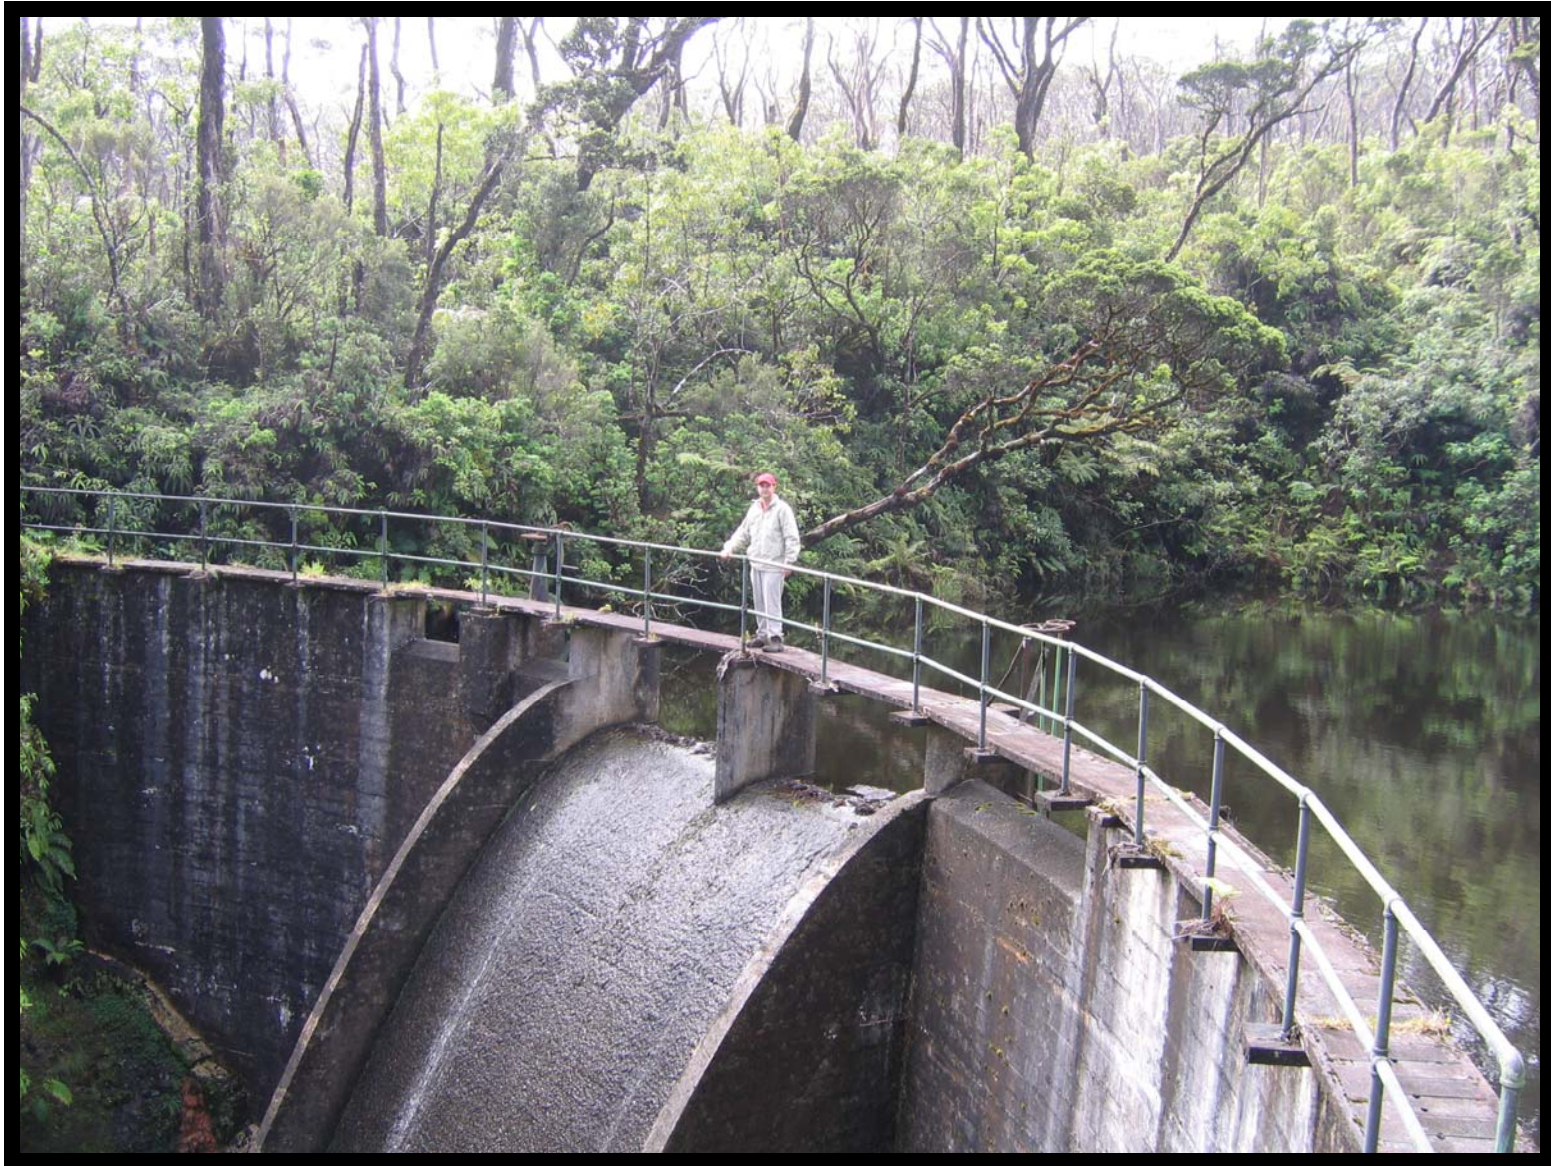
046 View of Crest

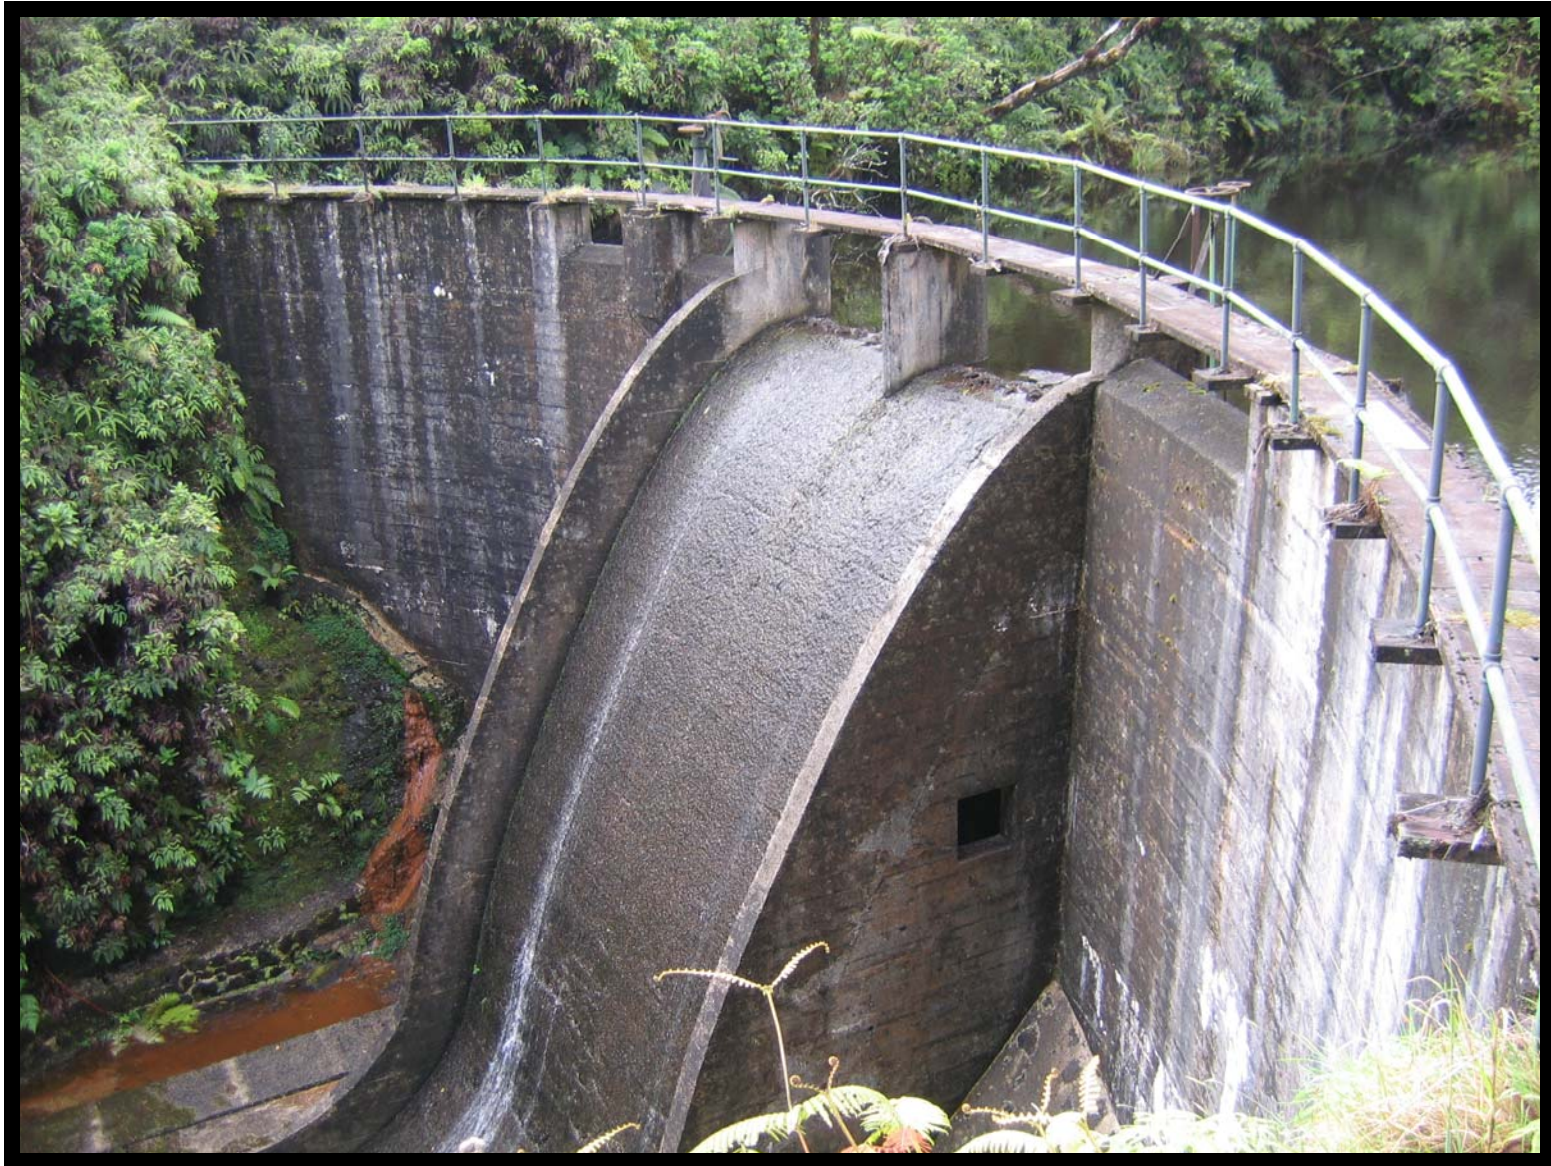
046 View of Concrete Arch Dam with Flip Bucket Spillway

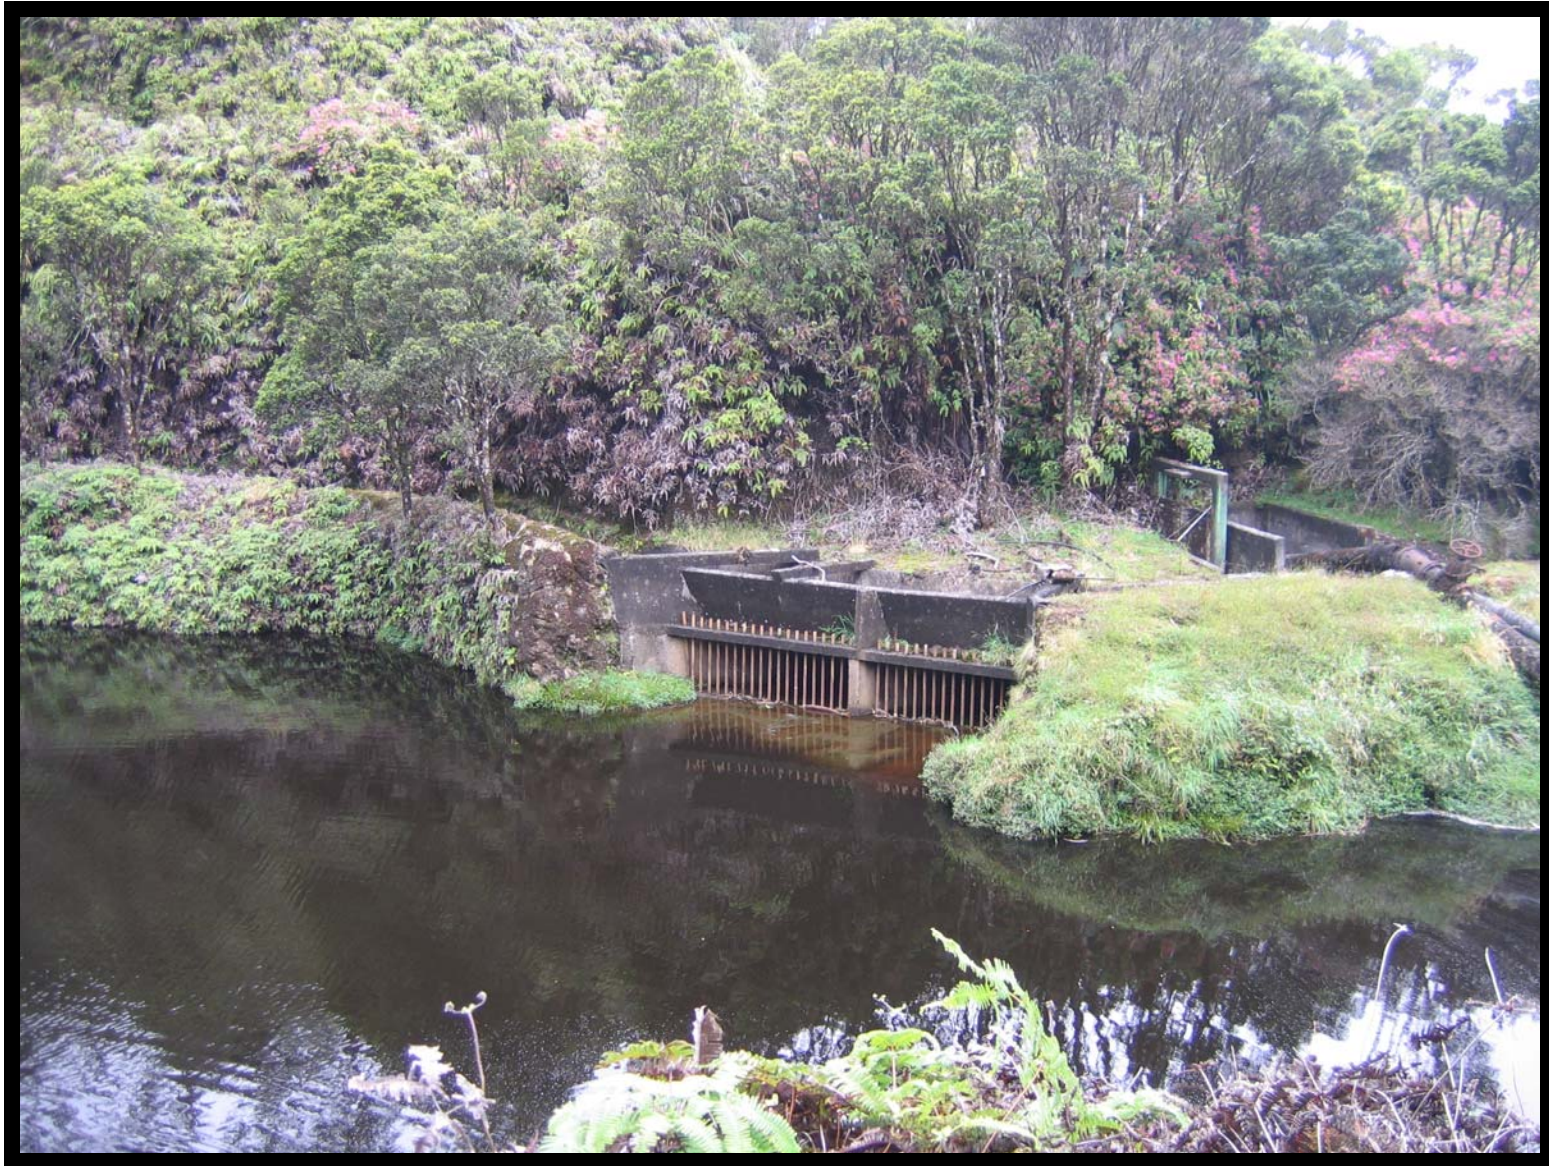
046 16 wide gated outlet structure adjacent to abandon diversion culvert.

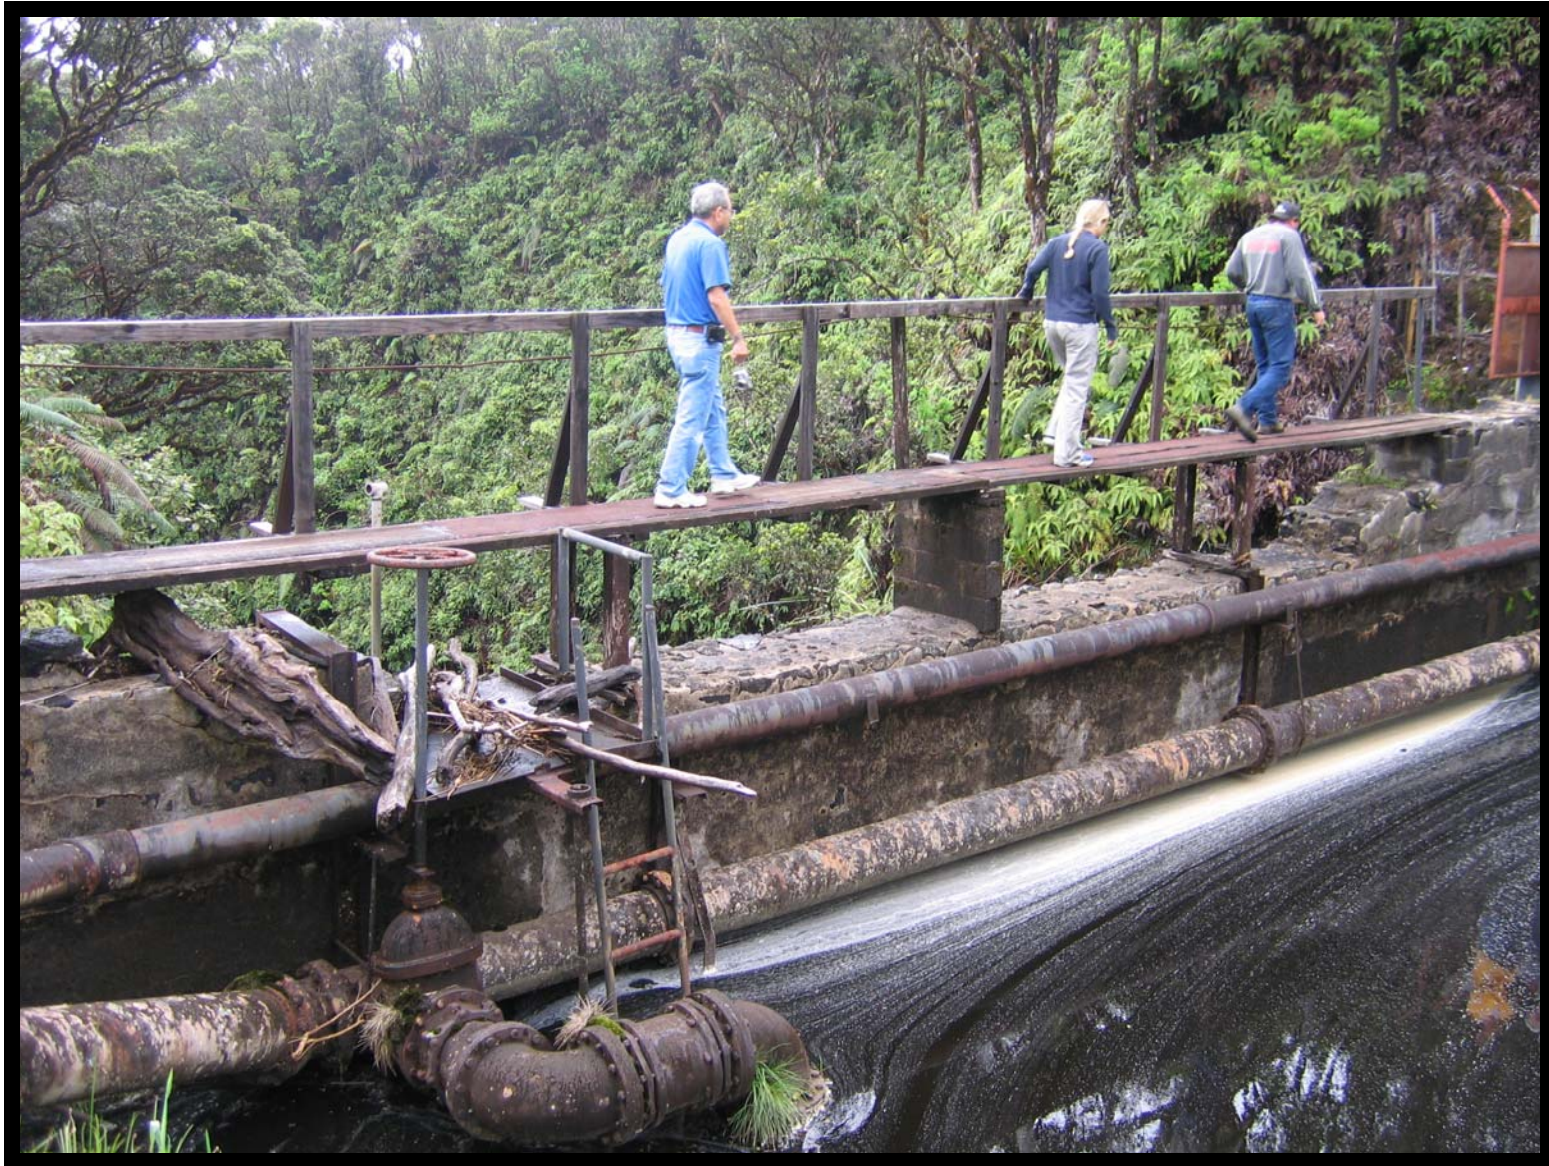
046 View of Diversion Dam (#1) Downstream of Dam #2.

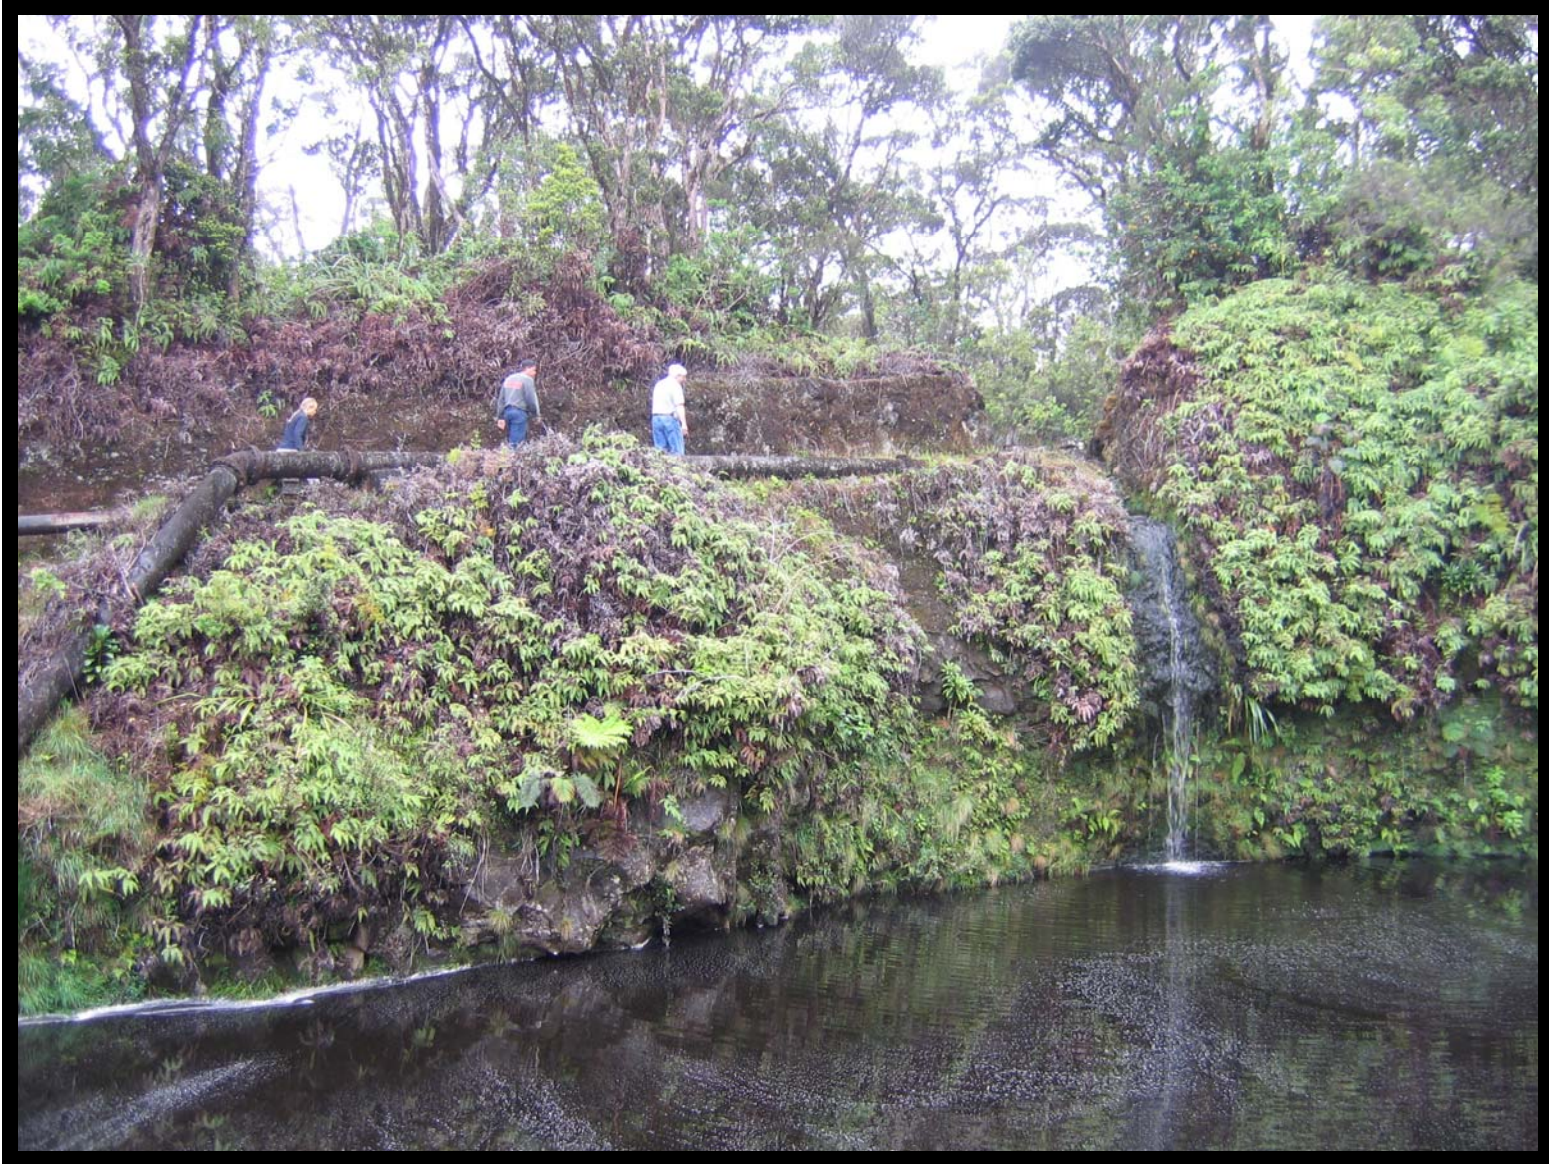
046 Outlet Collection Area Right Side

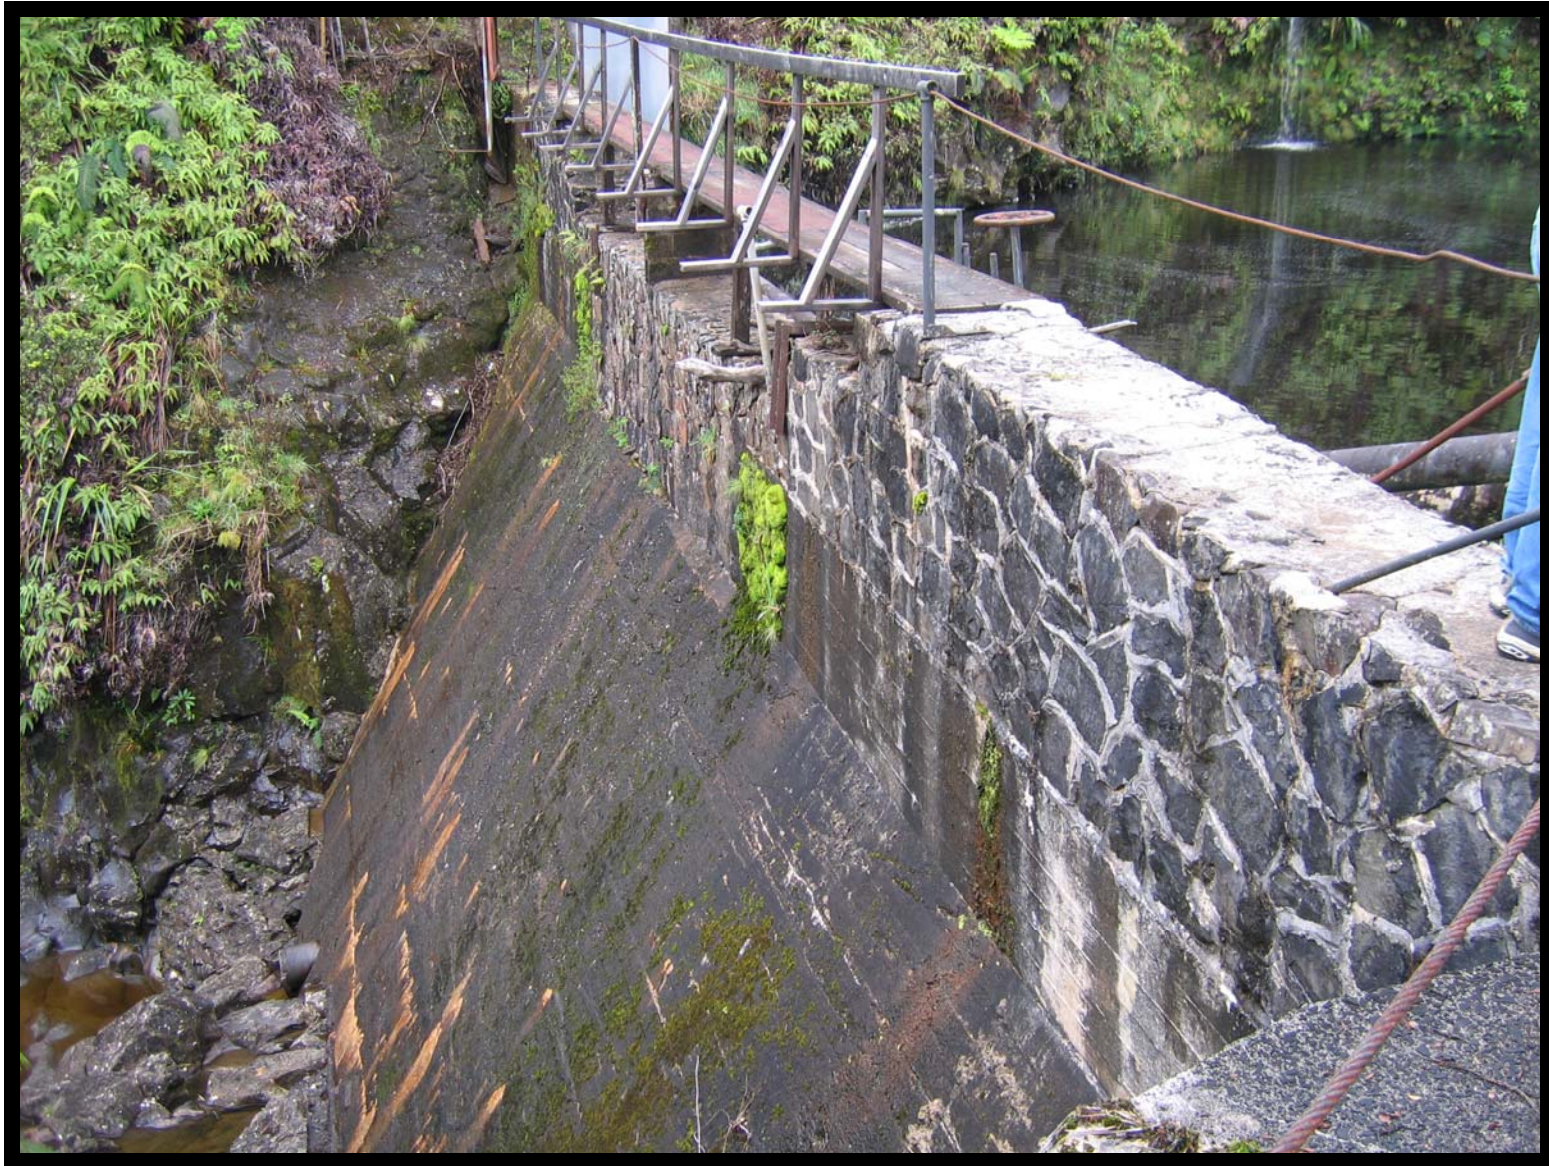
046 Diversion Dam downstream of arch dam. (Dam #1)

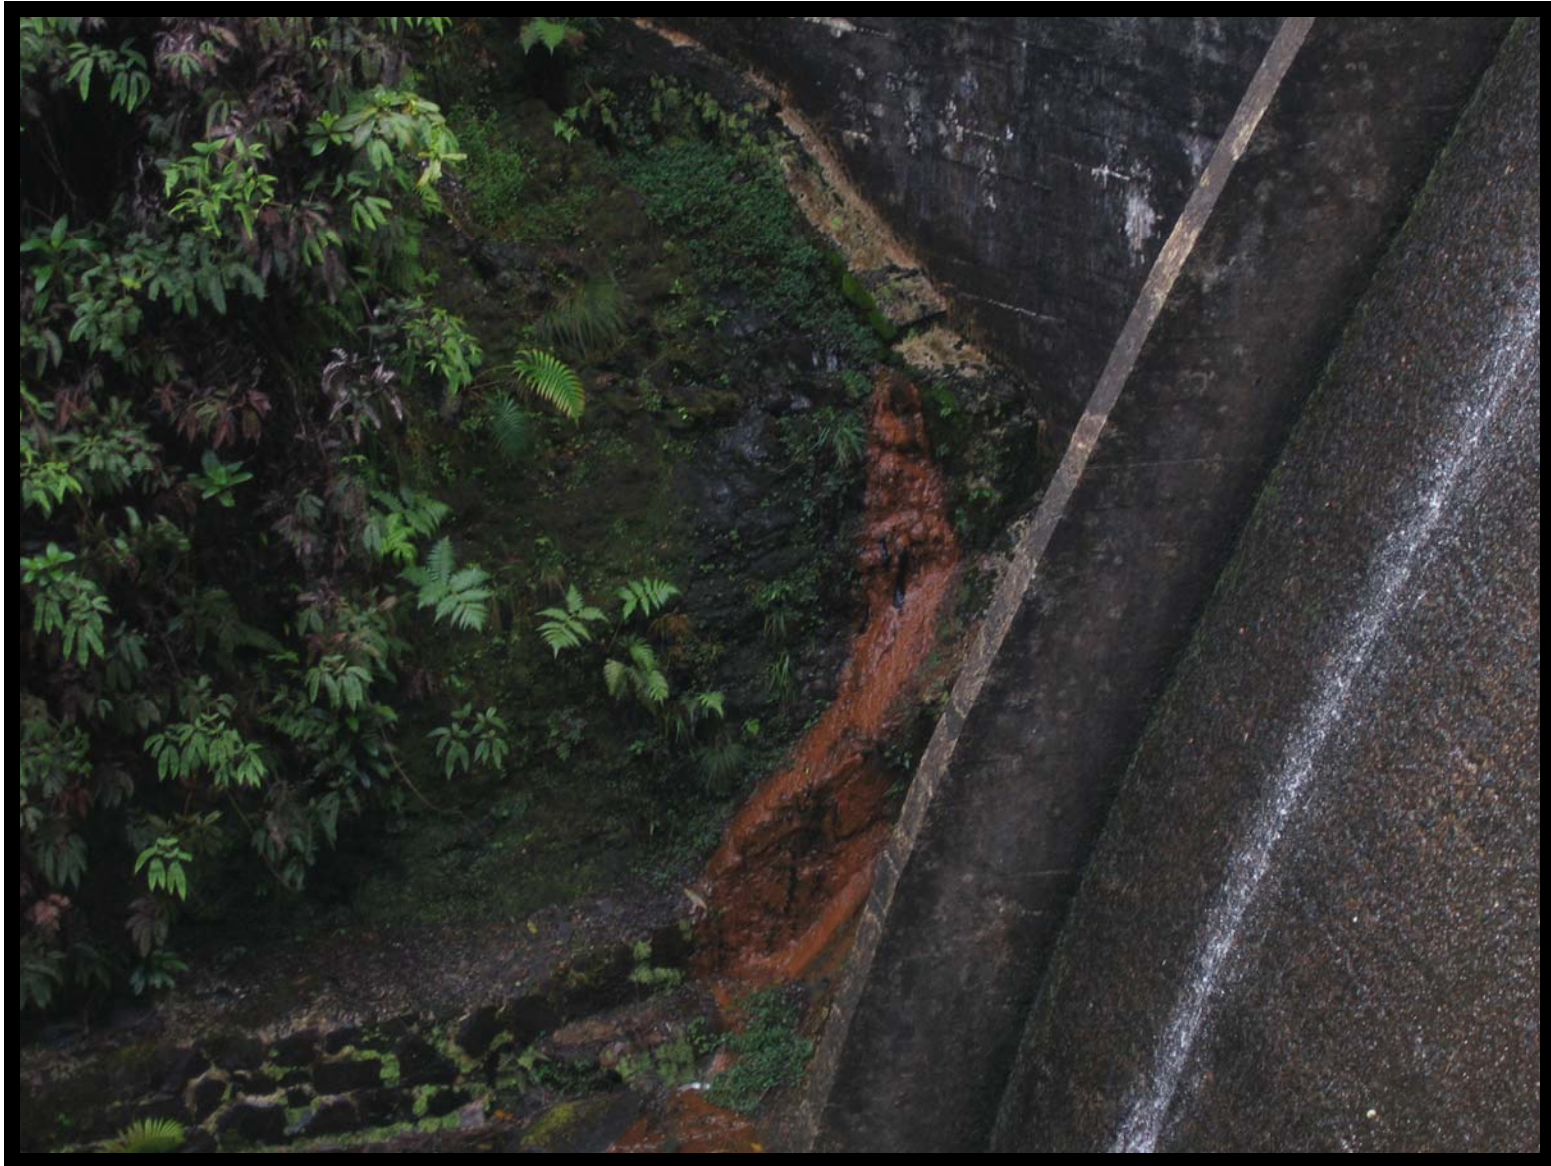
Seepage was observed at the right abutment toe, and it was a constant flow of less than 1 GPM. The seep was clear and appears to have been flowing for a long time based on the staining of rock at seep.

Slight seep noted along the right abutment toe area. This seep should be monitored and reported if significant changes in flow occur.

046 Slight seep (staining) along right abutment toe.

- a. The abutments/toe appeared to be in fair to poor condition and requires corrective action. The seep should be further evaluated.
- b. Seepage was observed. Monitor and conduct further investigation to locate the source of water and extent of any possible hazardous or developing condition.

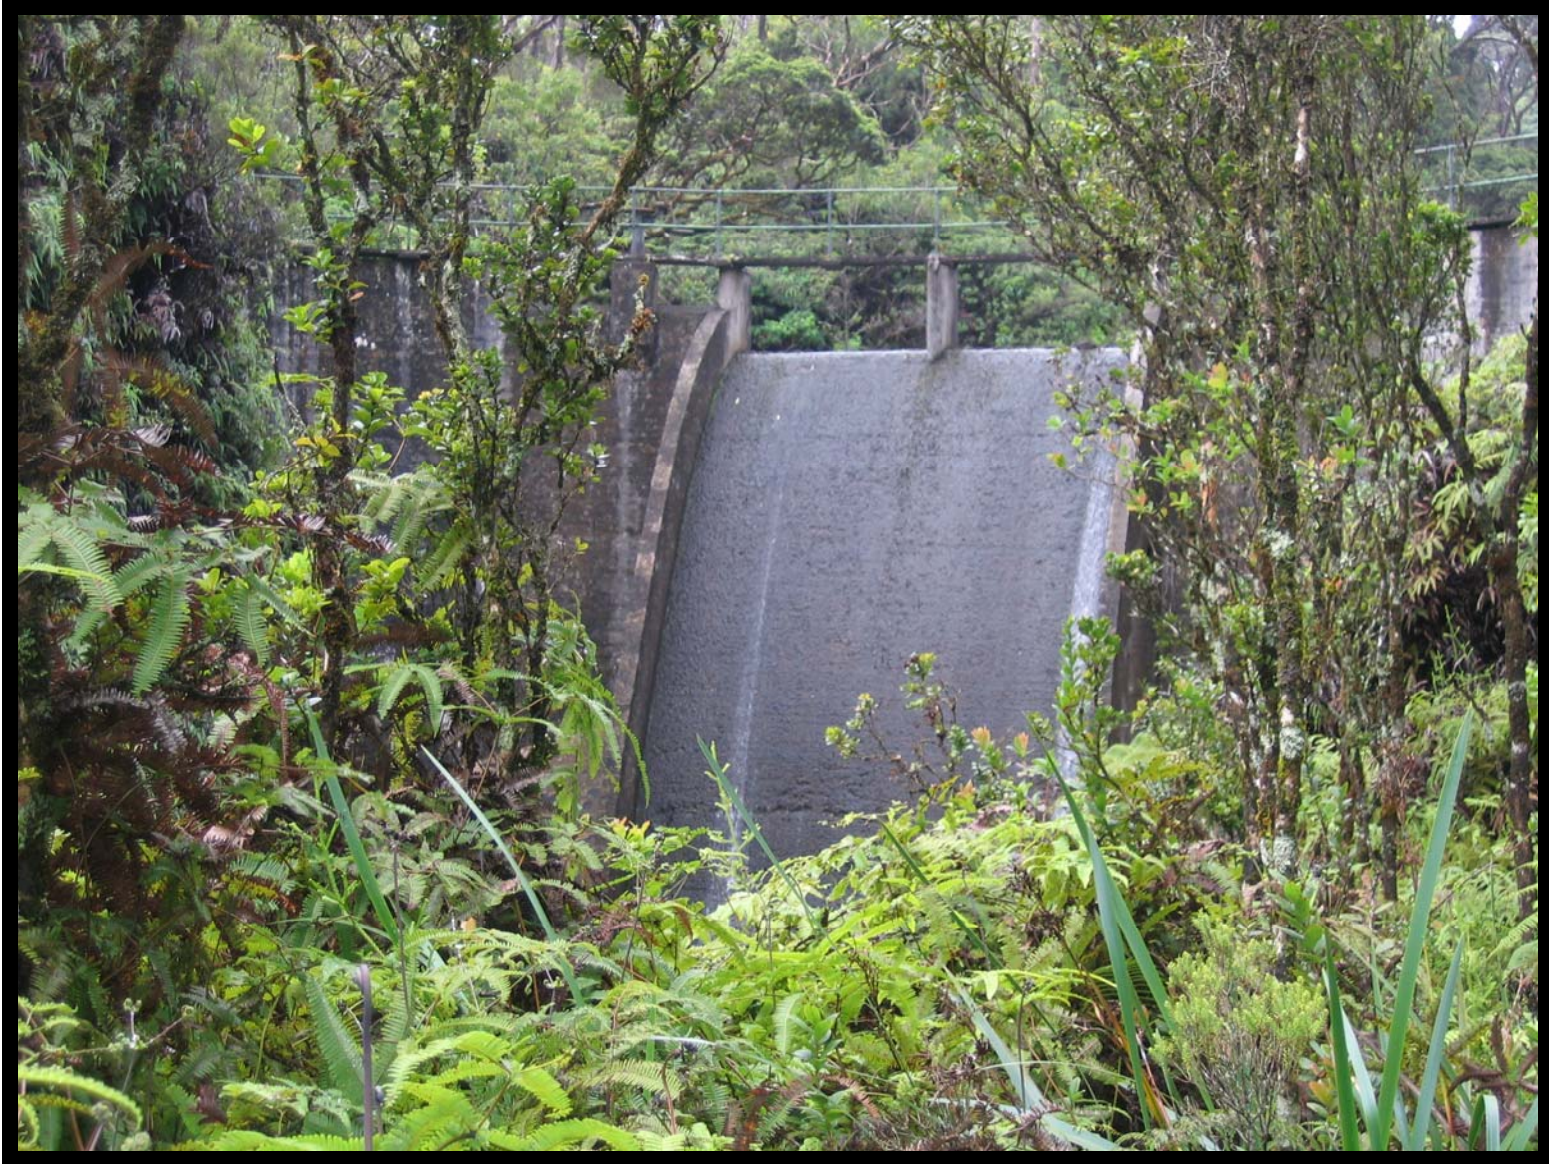
046 US View from Outlet Pool - View of arch dam from DS
